Chapter DHS 163

APPENDIX G

Conducting a Visual Inspection

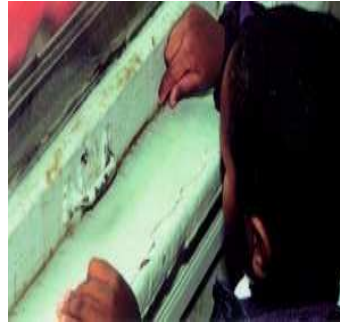
b. Mildew. A potential hazard is the formation of microbial growth on a painted surface. It is usually caused by excessive moisture. Mildew should be removed as a preventive measure to decrease the chance of paint film deterioration.

Paint affected by the mildew is deteriorated paint and must be repaired when an adhesion test determines that any layer is not securely bonded. To conduct an adhesion test, firmly press a 2" x 2" piece of masking tape to the suspect paint and rub the tape to adhere firmly. Lift up on one corner of the tape and remove the tape. If paint is evident on the tape, the paint is separating from the substrate or from underlying paint, and is not securely bonded.

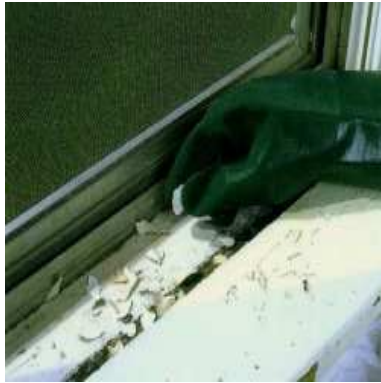
d. **Paint Chips and Other Paint Debris.** The presence of paint chips and debris that have not been proven to be lead-free are considered a hazard. They are evidence that paint is either deteriorated or subject to friction or impact. Visually inspect the floor, stairs, window wells/troughs and sills, and dripline for the presence of paint chips or other paint debris.

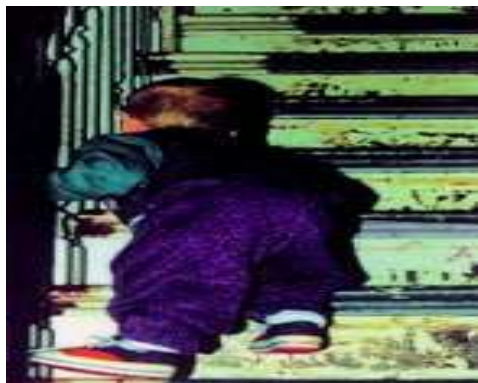
e. **Painted Friction or Impact Surface.** The friction and impact surfaces are evidenced by worn or chipped paint. The friction and impact of these surfaces can also result in dust-lead, which is not detected in a visual inspection.

Worn paint is often due to improperly hung doors, sticky window sashes, sticky drawers, etc. A source of dust-lead are windows that do not operate smoothly and doors that bind or otherwise contact the frame. To test for friction surfaces open and close painted doors, drawers and windows. Visually inspect doors, windows, trim, floors and stairs for evidence that the paint is worn or chipped.

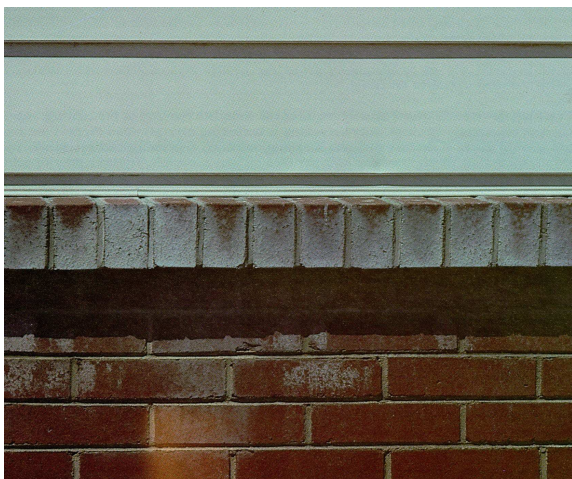
c. Chalking Paint. Chalking is the formation of a fine lead powder on the surface of a paint film. Almost all exterior oil paints are designed to eventually chalk in order to wash dirt away in the rain and provide a good surface for repainting. However, the chalking can also appear on the surfaces below the paint or on the ground. This chalking is usually caused by a failure to adequately prime or seal a porous surface, overthinning of paint, or exposure to sunlight.

Chalking paint is deteriorated paint and must be repaired.

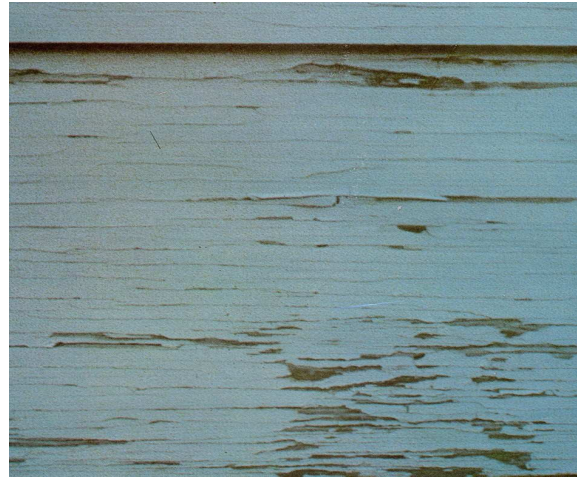
d. Checking Paint. Checking is a pattern of short, narrow breaks in the top layer of paint that is usually caused by a loss of elasticity. Plywood substrates can often cause checking.

Checking paint is deteriorated paint and must be repaired when an adhesion test determines that any layer is not securely bonded. To conduct an adhesion test, firmly press a 2" x 2" piece of masking tape to the suspect paint and rub the tape to adhere firmly. Lift up on one corner of the tape and remove the tape. If paint is evident on the tape, the paint is separating from the substrate or from underlying paint, and is not securely bonded.

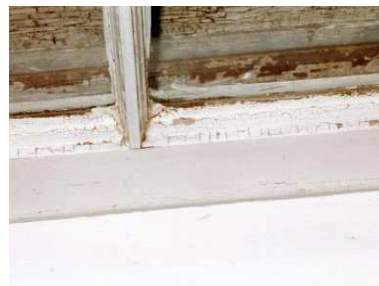
e. Chipping Paint. Paint chips are generally visible when chipping paint occurs. Chipping paint is paint that separates from the substrate due to either impact to the painted surface or poor surface preparation or paint failure.

Chipping paint is deteriorated paint and must be repaired.

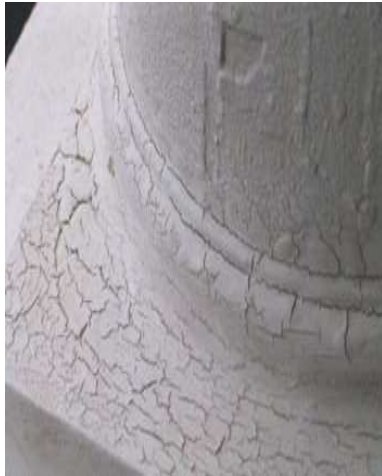
f. Cracking Paint. The cracks usually form parallel to the grain of the wood. Cracking paint is an advanced form of checking that usually occurs on surfaces with multiple layers of paint and includes breaks in the film that extend to the base substrate.

Cracking paint and cracked paint at a settlement crack is deteriorated paint and must be repaired when an adhesion test determines that any layer of paint is not securely bonded. To conduct an adhesion test, firmly press a 2" x 2" piece of masking tape to the suspect paint and rub the tape to adhere firmly. Lift up on one corner of the tape and remove the tape. If paint is evident on the tape, the paint is separating from the substrate or from underlying paint, and is not securely bonded.
